RE: Murphy v. Southern Energy Homes

On October 24, 2007 I inspected the residence of Kelly Murphy located at 5489 Washington Ferry Rd., Montgomery, AL.

Evaluation of 5/16" Vinyl Covered
Gypsum (Murphy Home) to ASTM C1396

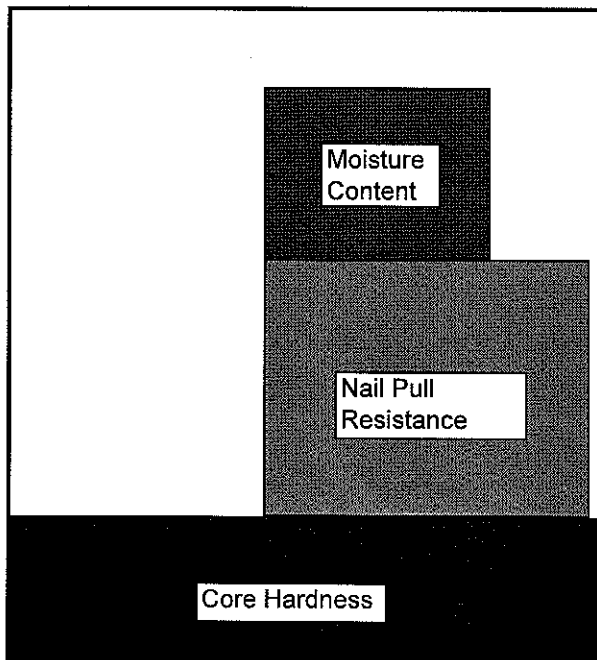
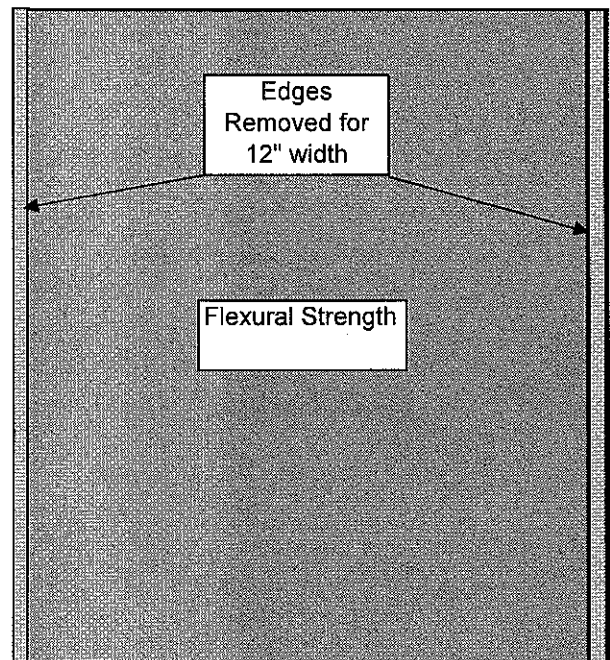
Typical Sample Removal Locations

Evaluation of the Flexural Strength; Core Hardness; Nail Pull Resistance; and Moisture Content of the 5/16" vinyl covered gypsum board taken from an exterior wall in the Murphy Home. *The residence and location of the material used for this test was provided to PEI by mSolve Building Science Service.*
